Case Study: Major KSA Based Rig Operator

Major KSA Based Rig Operator

Date in: 6 June 2016

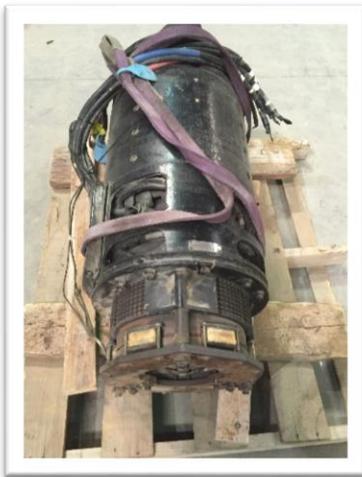
The parts were removed and sent to dm+ for inspection and at our 2000m² facility in which our engineers discovered the End Bells and Brake Hubs to be badly worn.

Hook Motor
(left)

Utilising parts from our on-site stock at our Bahrain facility, which is regularly replenished to minimise maintenance and repair lead times, we were able to very quickly replace the end bells and brake hubs in addition to overhauling the motors and carrying out essential repair work.

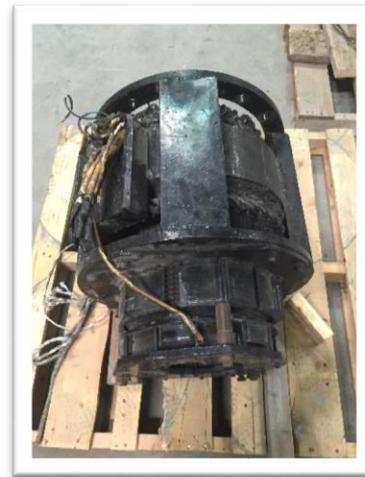
Boom motor
(right)
Complete
with brake
unit

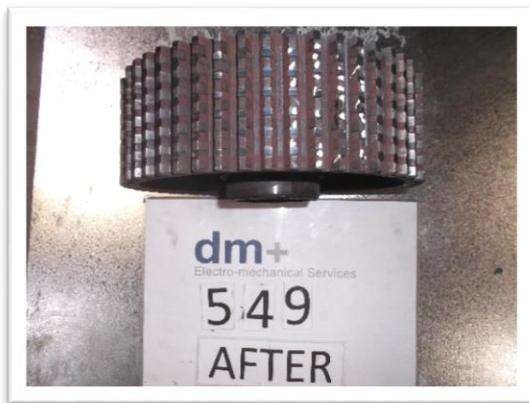
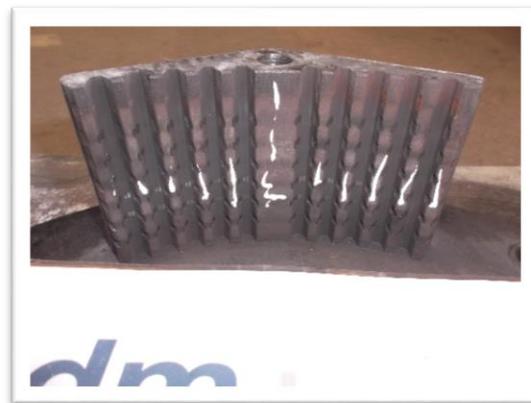
A selection of images demonstrating the completed repairs can be seen below:

Once the essential repair work had been completed the motors and brakes were tested at our on-site testing rig (featuring Low Voltage Test Panel), to check the quality of the work and ensure that the motors and brakes were operating at maximum efficiency before being dispatched back to the rig.
